## **DIAGNÓSTICO DE FALLAS EN PAVIMENTOS URBANOS MEDIANTE EL MÉTODO PCI: EL CASO DE LA CALLE ELOY ALFARO EN JIPIJAPA**

### **DIAGNOSIS OF URBAN PAVEMENT FAILURES USING THE PCI METHOD: THE CASE OF ELOY ALFARO STREET IN JIPIJAPA**

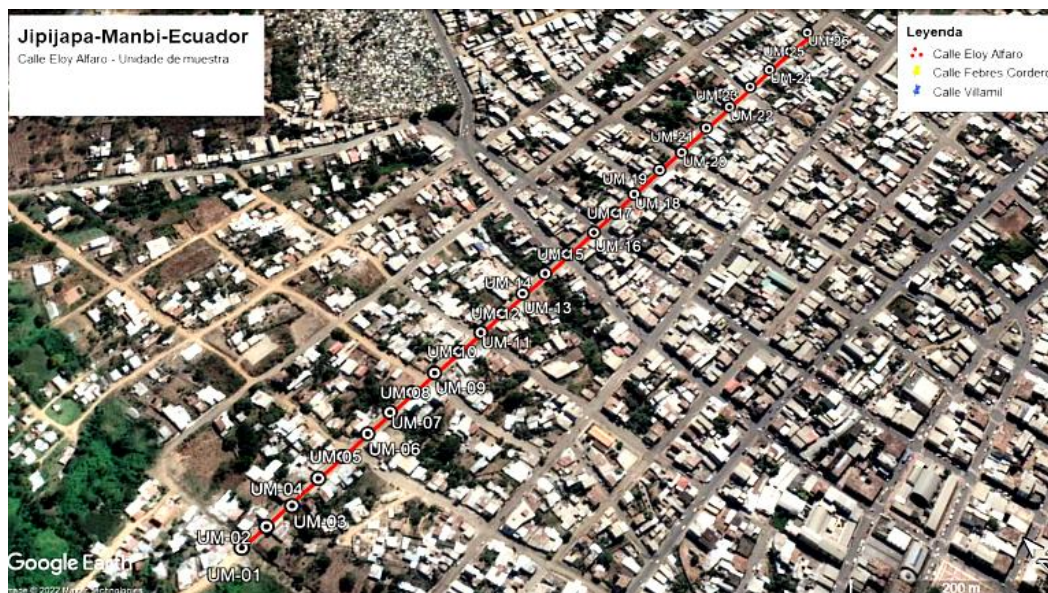
**Figure 1.** Location of the study section and sequence of sampling units.

*Note.* The satellite image served as the cartographic base to delineate SUs on the carriageway and to document the visual survey; the analysis was performed with representative sampling ( $n = 8$ , 95 % confidence,  $\pm 5\%$  error). Source: Google Earth; authors' elaboration.

The evaluable population was defined as the set of sampling units (SU) within the paved section; 26 SUs were identified, and a representative sampling design was applied with 95 % confidence and  $\pm 5\%$  sampling error, assuming a standard deviation of 8 PCI points for a first survey. As a result, eight georeferenced SUs were selected and assessed. See Figure 1 for the location of the section and the
